**Flood Control Project Maintenance  
Levee Inspections**

**Fall 2012 Levee Maintenance Deficiency Summary Report**

**Reclamation District No. 0551 Pearson**

**Levee Inspection Report By Mile - Fall 2012**

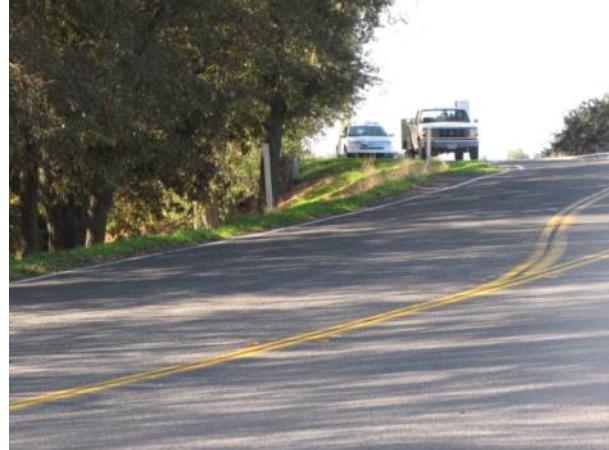
Levee Mile Report Line	4
Start Levee Mile	0.00
End Levee Mile	0.00
Location	Land Side
Category	Earthen Levee
Item	Vegetation
RD 551 Looking downstream from levee mile 0.00 landward. Photo taken 11-08-2012.	
phillips_f_20121119_386.jpg

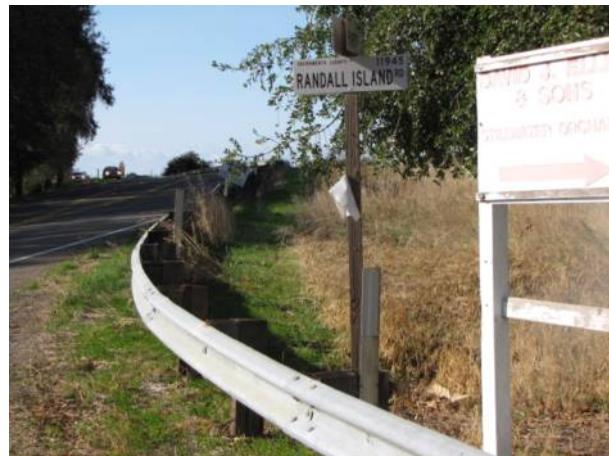
Levee Mile Report Line	5
Start Levee Mile	0.00
End Levee Mile	0.00
Location	Water Side
Category	Earthen Levee
Item	Vegetation
RD 551 looking downstream from levee mile 0.00. Photo taken 11-08-2012.	
phillips_f_20121119_384.jpg

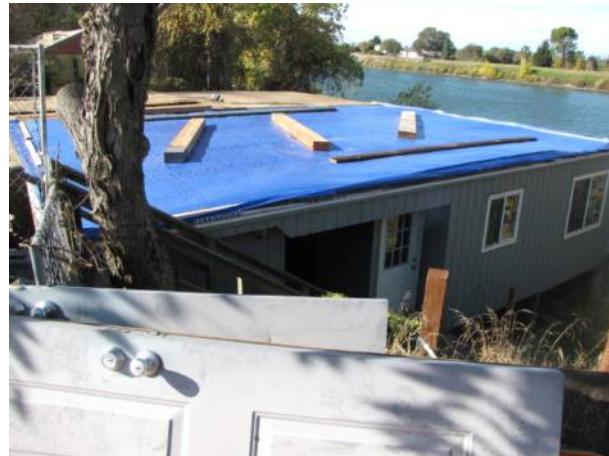
Levee Mile Report Line	13
Start Levee Mile	0.50
End Levee Mile	0.50
Location	Water Side
Category	Earthen Levee
Item	Encroachments
RD 551 LEVEE MILE 0.49 unauthorized building construction waterside of levee section. Photo taken 11-08-2012.	
phillips_f_20121119_385.jpg

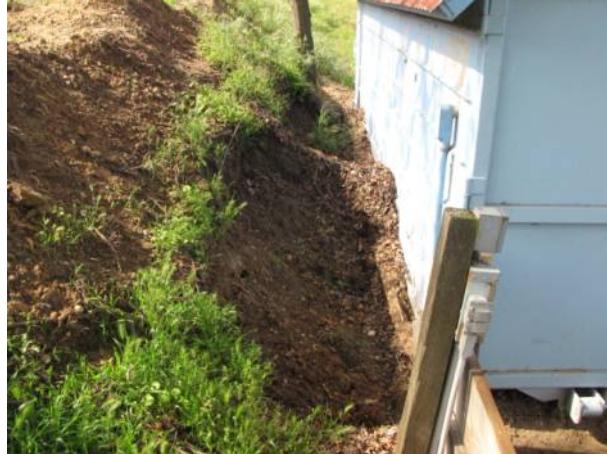
Levee Mile Report Line	18
Start Levee Mile	0.60
End Levee Mile	0.60
Location	Water Side
Category	Earthen Levee
Item	Erosion / Bank Caving
Property owner has excavated into toe of levee section at base of structure. Photo taken 3-30-2012. This property has been sold to new owner. District will notify new owner to make repairs to damage.	
phillips_f_20120911_229.jpg
